FAULT CARRYING CAPACITY - SANTON 200A ADMIRALTY TYPE ROTARY SWITCH, (U)

ADMIRALTY ENGINEERING LAB WEST DRAYTON (UNITED ...

25 SEP 1964

REPORT NO. 2423/3776/I.

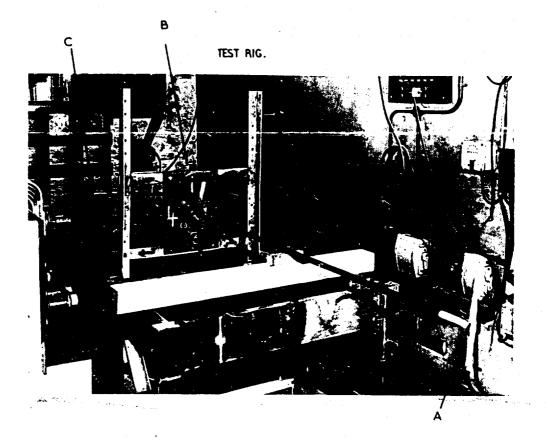
FIG.I.

The switch was mounted unenclosed as shown in Fig. 1, and the batteries of the test station were grouped to supply 628V. Connections were made to allow current to flow through the 2 pairs of contacts (2 moving, 2 fixed) in series, which formed one way or "coll" of the switch. Resistances were arranged to give prospective currents of about 5000A, 10 000A, 15 000A and 20 000A, but no industance was added to the test circuit, and the time constants were of the order of 0.004s. As the time of application was 0.25s, the current rese to the full prosective level in each test. Although not specified in the requirements, it was decided to differentiate between especity for "through", and for "closing" current. For the former test the switch was closed under open circuit conditions, the foult breaker being closed subsequently to complete the circuit, and remaining closed for 0.25s. For the latter test the fault breaker was initially closed, and the Santon switch was closed by hand (For safety precautions see Fig. 1). The fault breaker was set to open 0.25s after the Santon switch was closed.

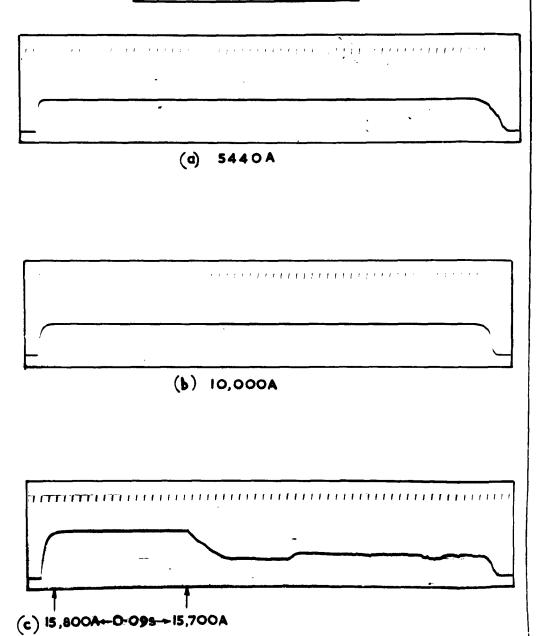
FIG. 4.

Tests 2 and 4 indicate that the switch could be closed on a prespective fault current of 10 000A, and carry this consistently for the required time. This is confirmed by oscillograms shown in Fig. 4(a) and (b). In Test No. 6, the switch was closed on a prespective current of 15 000A, and arcing occurred which reactically destroyed the contacts. Fig. 4(c) shows a slight decrease of current as the contacts became hot, followed, after 0.09s, by violent arcing.

No sign of mechanical parting, due to magnetic effect, of the contacts was apparent from the oscillograms taken when the switch carried current successfully for 0.25s, Fig. 3(a) (b) and (c). Fig. 4(a) and (b). The two cases in which the switch failed, show a gradual decrease of current until the contacts begin to arc, probably as a rosult of developing hot spots, Fig. 3 (d) and Fig. 4(c). This condition may have been accelerated in the second case when the switch was closed on the fault current, by initial pitting of the contacts. If failure of the contacts was due solely to heating, this effect would be the same for a given current and conditions, either a.c. or d.c. It would be advisable to verify this by some comparative a.c. tests, and these will be undertaken as soon as plent is available.

OSCILLOGRAMS OF CURRENT.

SWITCH CLOSING ON, AND CARRYING FAULT CURRENT FOR 0-25 s.
